PESTICIDE INPUT EFFICIENCY

Sprayer testing ensures even outputs

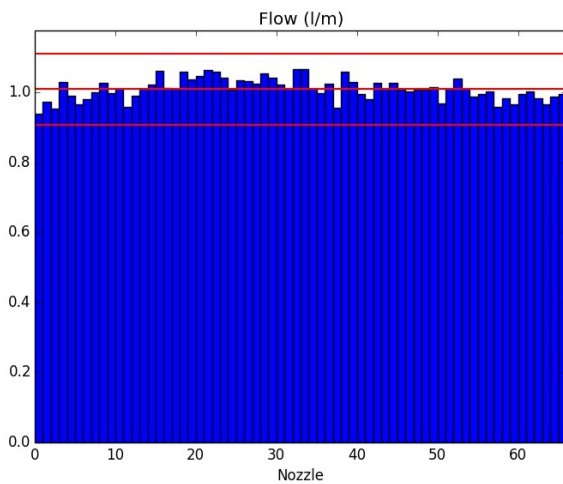
Figure 1: Shows the nozzle output in litres/min, across the boom from left to right, as viewed from behind Leo’s sprayer. The middle horizontal red line represents the average flow (L/min). The upper and lower horizontal red lines represent +10 per cent or -10 per cent of the average flow.

The lower the CV, the more even the sprayers output is across the boom. CV’s of less than 15 per cent are generally regarded as acceptable for sprayer outputs. The CV achieved by Leo’s sprayer was 10.34 per cent, which was a very good result.

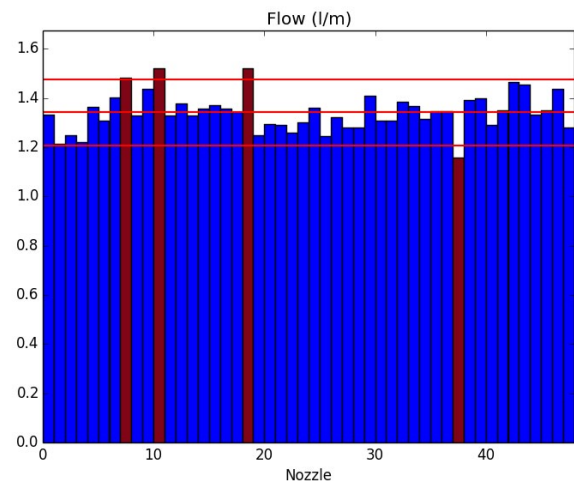
Figure 2 shows that three of the nozzle outputs for this

spray rig were producing flowrates more than 10 per cent above the average flowrate. Typically this will be due to nozzle wear and can be fixed by replacing the nozzles with new ones.

Figure 2: Nozzle outputs from another one of the sprayers tested. This figure also shows the nozzle output in L/min, across the boom from left to right as viewed from behind the sprayer. The middle horizontal red line represents the average flow (L/min) the upper and lower horizontal red lines represent + or - 10 per cent of the average.

The CV for the nozzle outputs in Figure 2 was 22.5 per cent, demonstrating it doesn’t take many nozzles not performing to specifications to impact on the evenness of the output.

Figure 2 also highlights that one of the nozzles is producing a flowrate more than 10 per cent below the average, which is a concern as this would result in under dosing.

A reduced flowrate may be due to a blockage in a non-drip valve or dirty nozzle filters, which can easily be fixed with a quick clean. However if the reduced flowrate is occurring close to the end of a boom section, particularly across more than one nozzle, it could be due to reduced pressure in the spray line, which may require modifications to the plumbing.
