PESTICIDE INPUT EFFICIENCY

Sprayer testing ensures even outputs

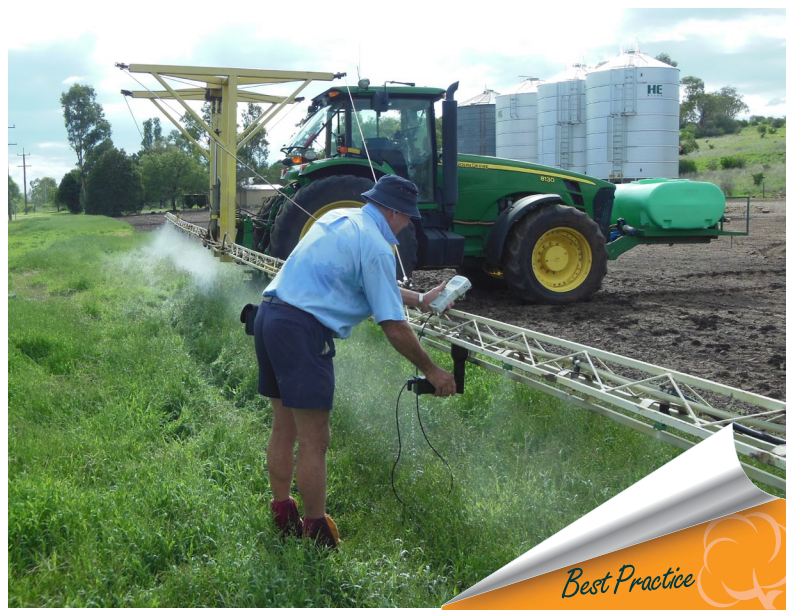
"When you look at the outputs on the graph, make sure you know how the boom sections are plumbed, and how many nozzle are on each section."

“This helps to identify where nozzle wear occurs or where restriction in flow may be happening due to the plumbing,” said Bill.

By comparison, the CV obtained for many of the other sprayers tested was above 20 per cent. Often this was due to just a few nozzles with flowrates that were too high (due to wear) or some that were too low (due to plumbing restrictions).

spray rig were producing flowrates more than 10 per cent above the average flowrate. Typically this will be due to nozzle wear and can be fixed by replacing the nozzles with new ones.
